JK-GEN 384-12
ERRATA SHEET

Altos Audio

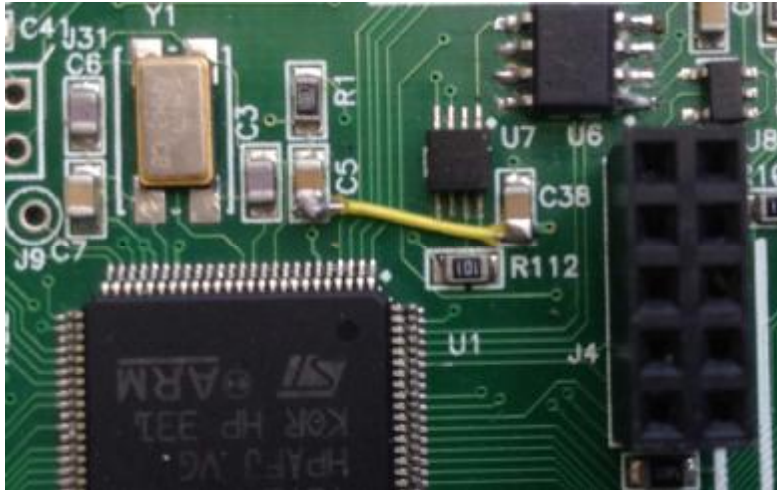
2. Internal MCLK is not always stable at 48/96/192/384 kHz.

Sometimes, the internal main clock is not stable at 48x sample rate scale.
Actually for PCB Rev. 1.3 and 1.3a.

- a) Open the case and check if the wire jumper exists:

If it exists – you do not need to do anything. If it does not exist – continue.

- d) Put short wire on the top side, as it shown above.:
