# Counterfeit Examples

## Electronic Components

Counterfeit Components Avoidance Program

Appendix A-6, Rev. E

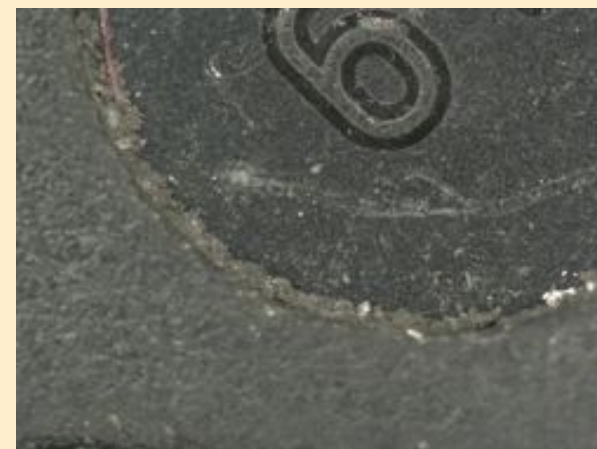
- This is not how bottom of mold mark usually look.
- Looks like top coating material ran to bottom or a mold defect.
- Requires more analysis.

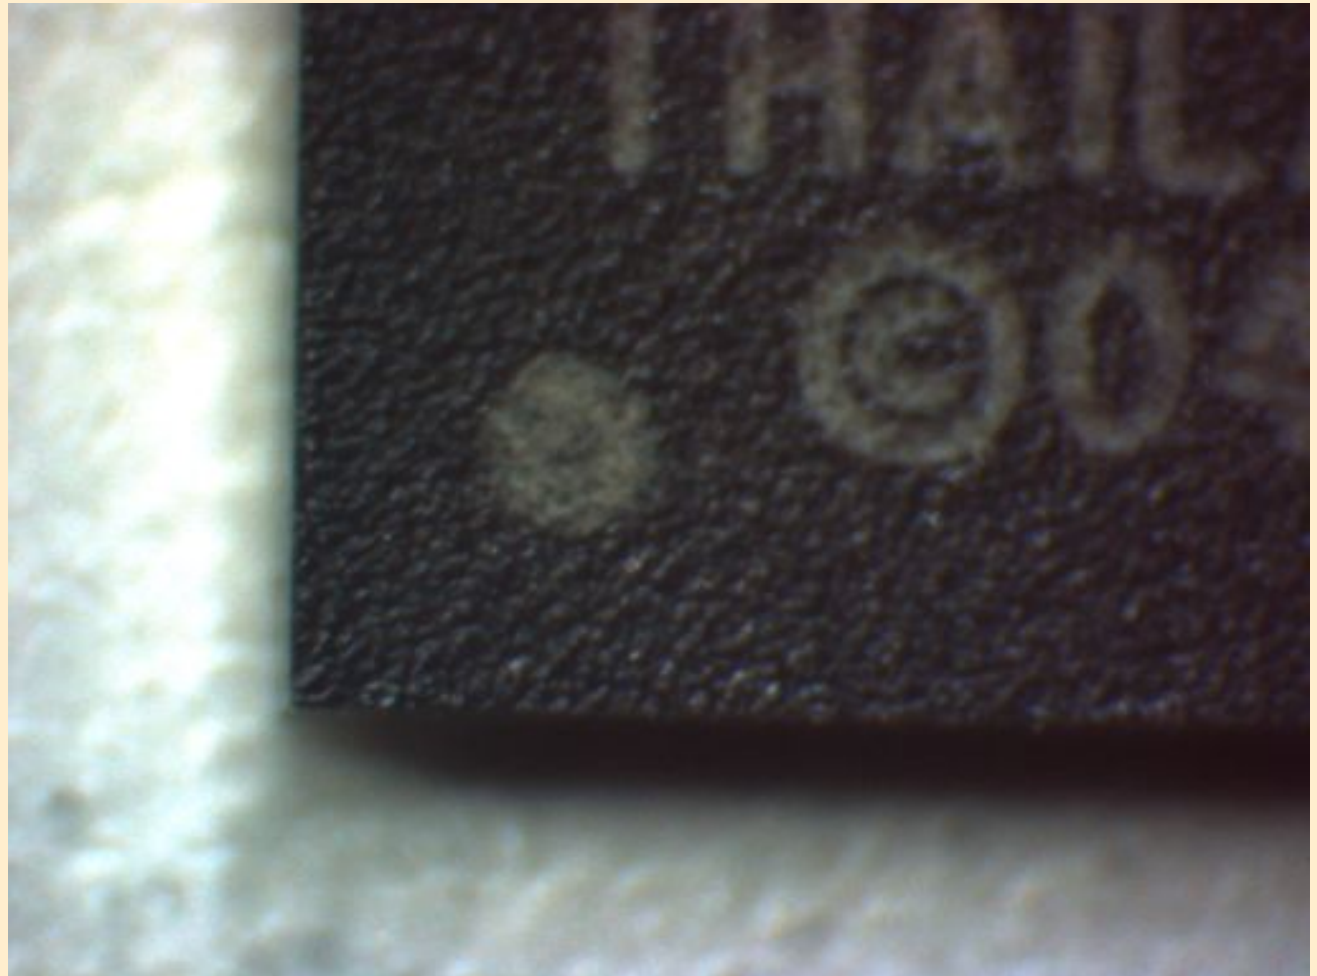
Almost certainly  
blacktopped.

See fake pin 1 ident.

Needs scrape test  
and HST to verify.

No reason to miss  
these sloppy jobs.

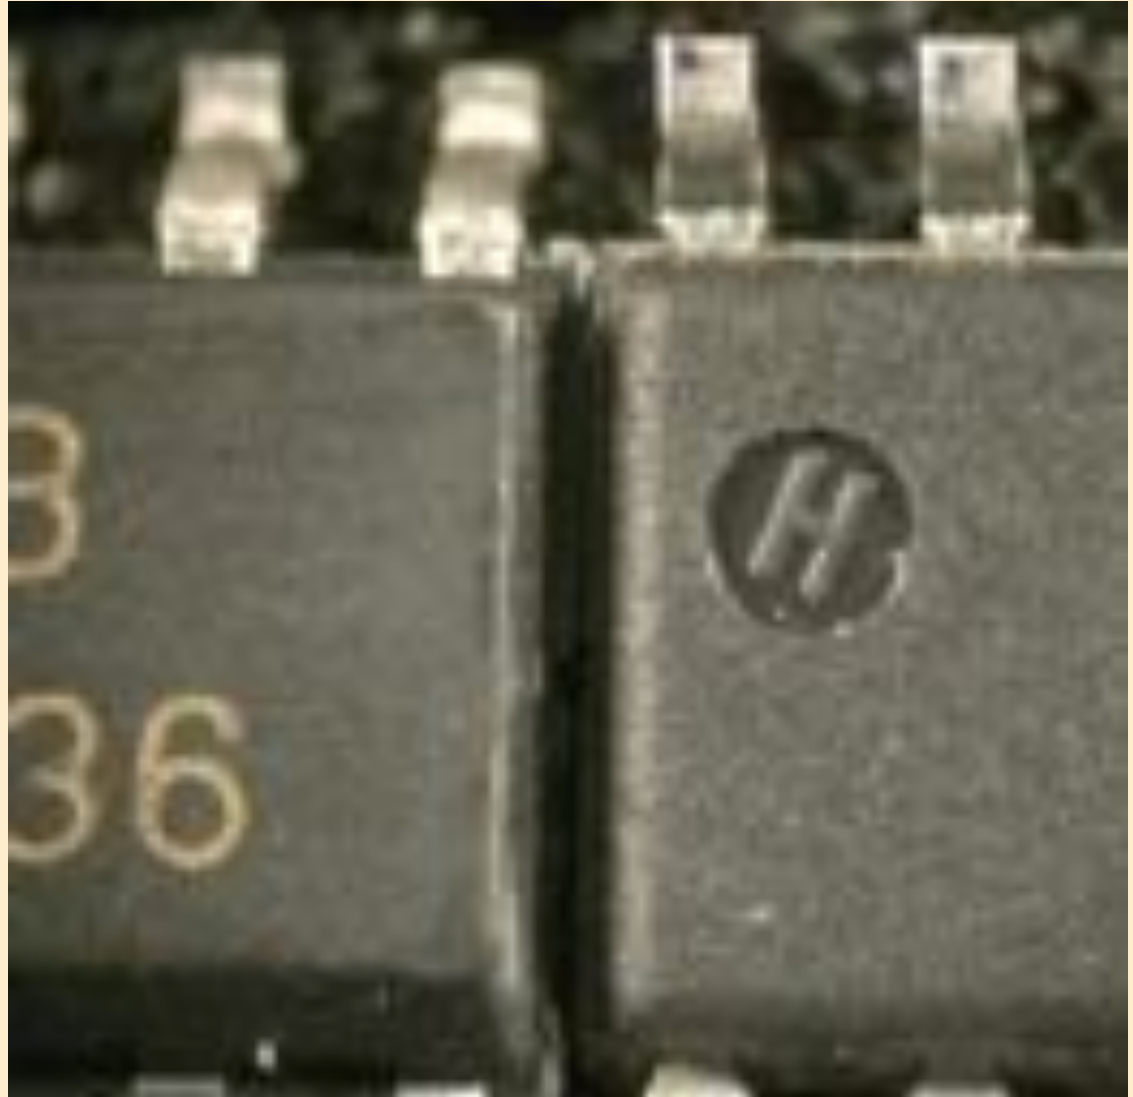
- Important to compare top and bottom in one photo.
- Surfaces show difference in texture.
- This demands aggressive search for top coating, scrape & HST.

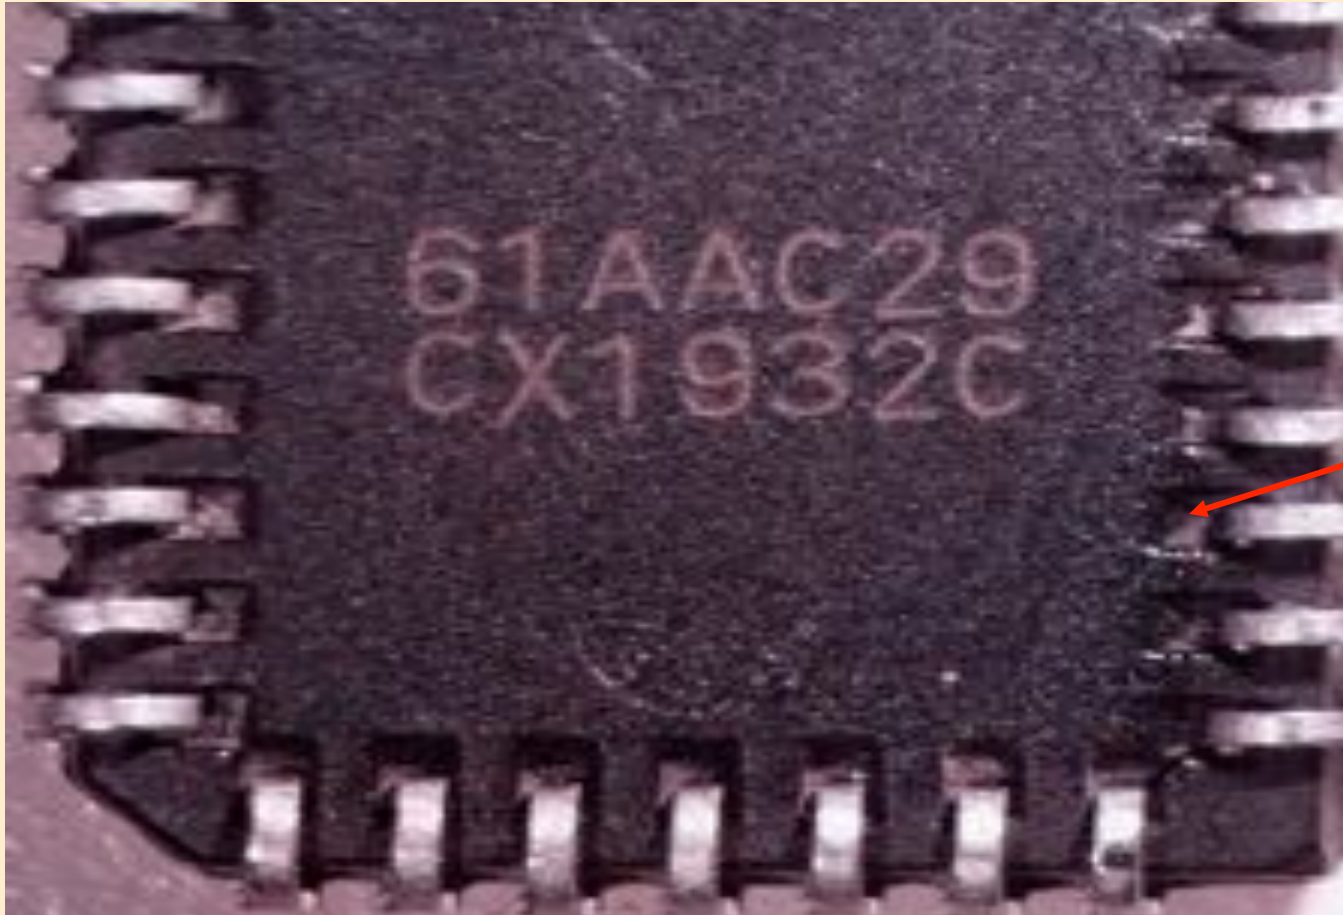
Look at the black shiny paint substance in the lower right side, the mold pin cavity is almost gone, see the bent leads, it may have been painted over to hide sanding marks and then fraudulently remarked

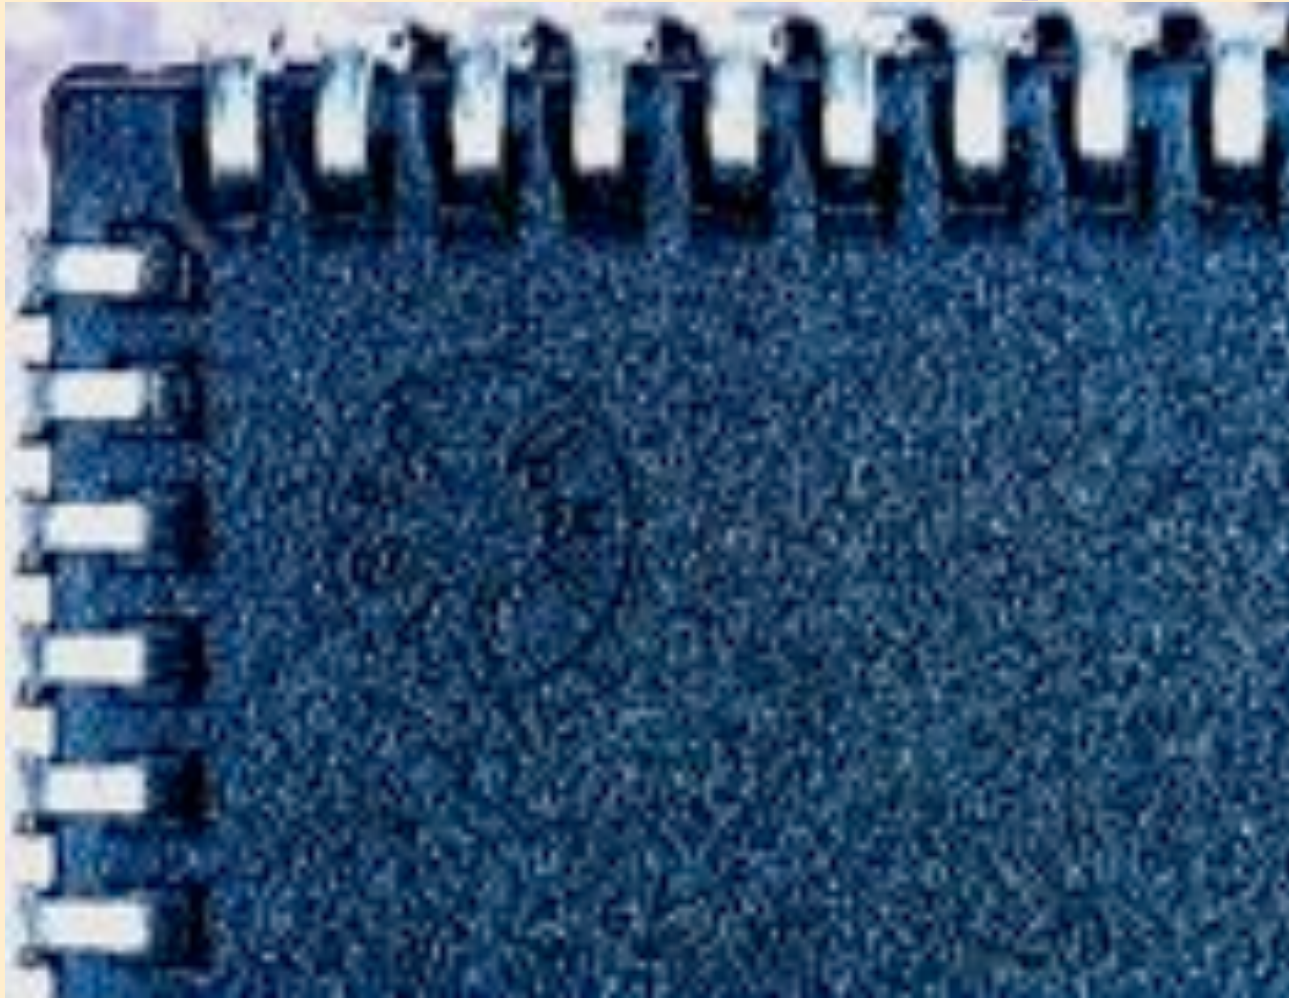
Obviously coated as attested by the covered mold mark and black residue around the end of J leads.

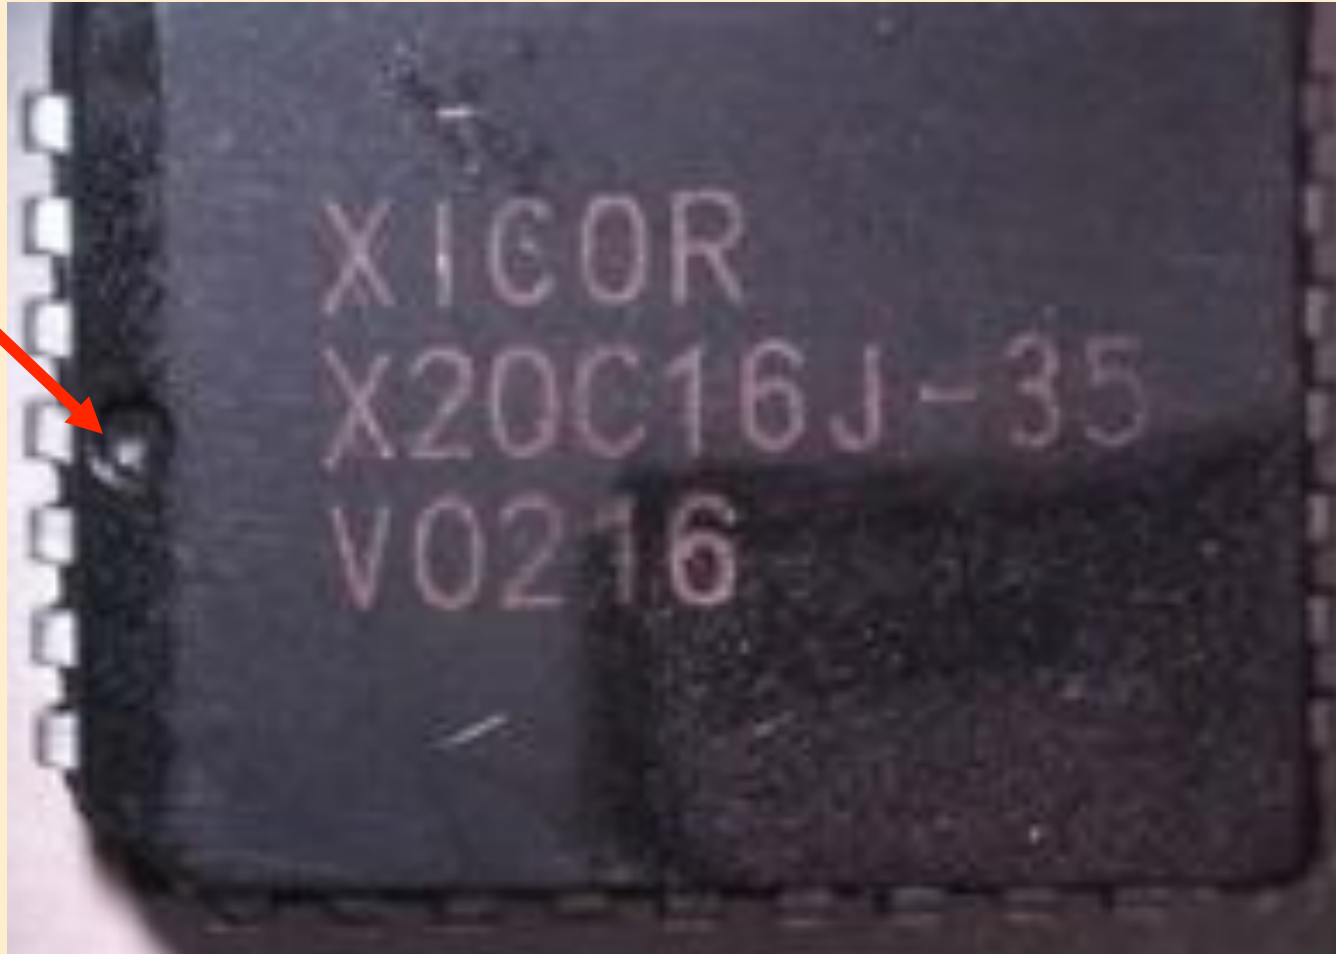
Blacktop removed with acetone

Lower right quarter revealing the actual surface, arrow points at the pin mold cavity is filled

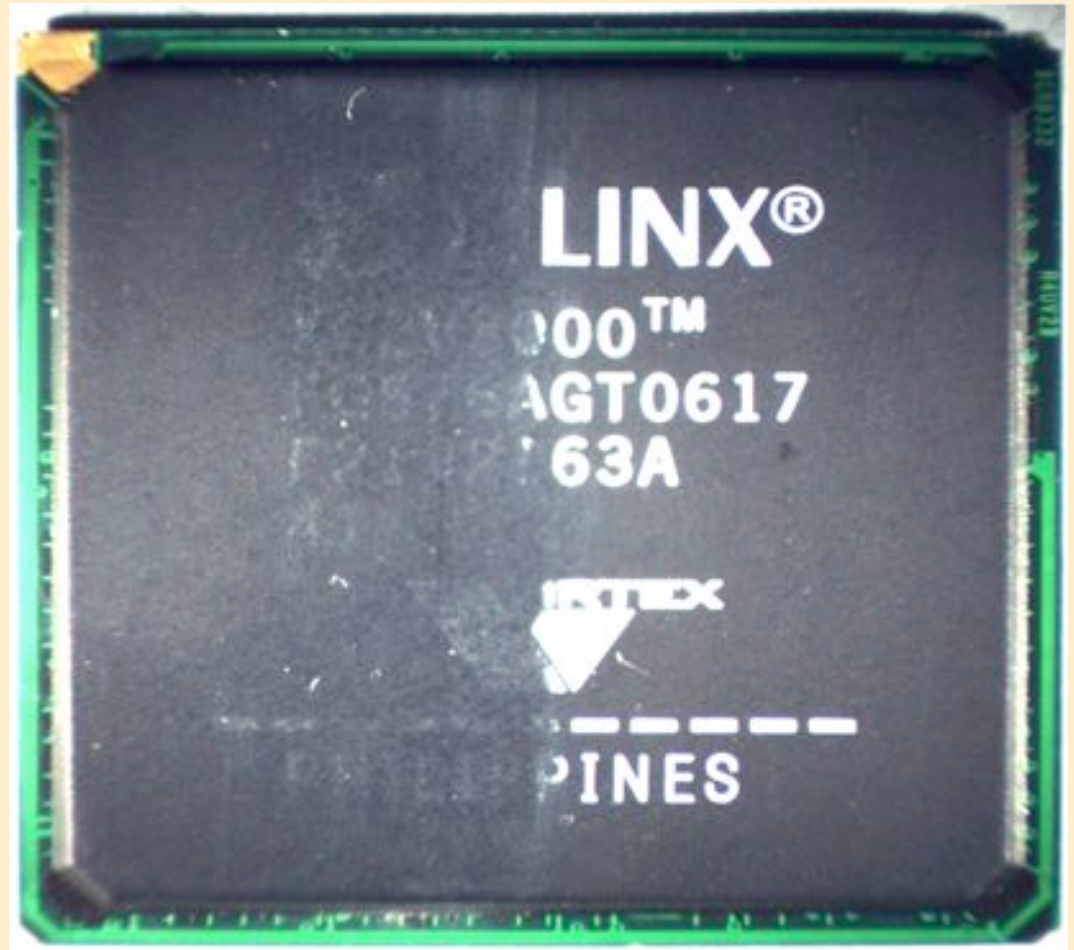
- Acetone-resistant blacktop
- Four different solvents were tried.
- Dynasolve 711 removed markings; but did not remove blacktopping
- Dynasolve 750 did not remove black coating.
- Unsatisfied, another solvent was tried.

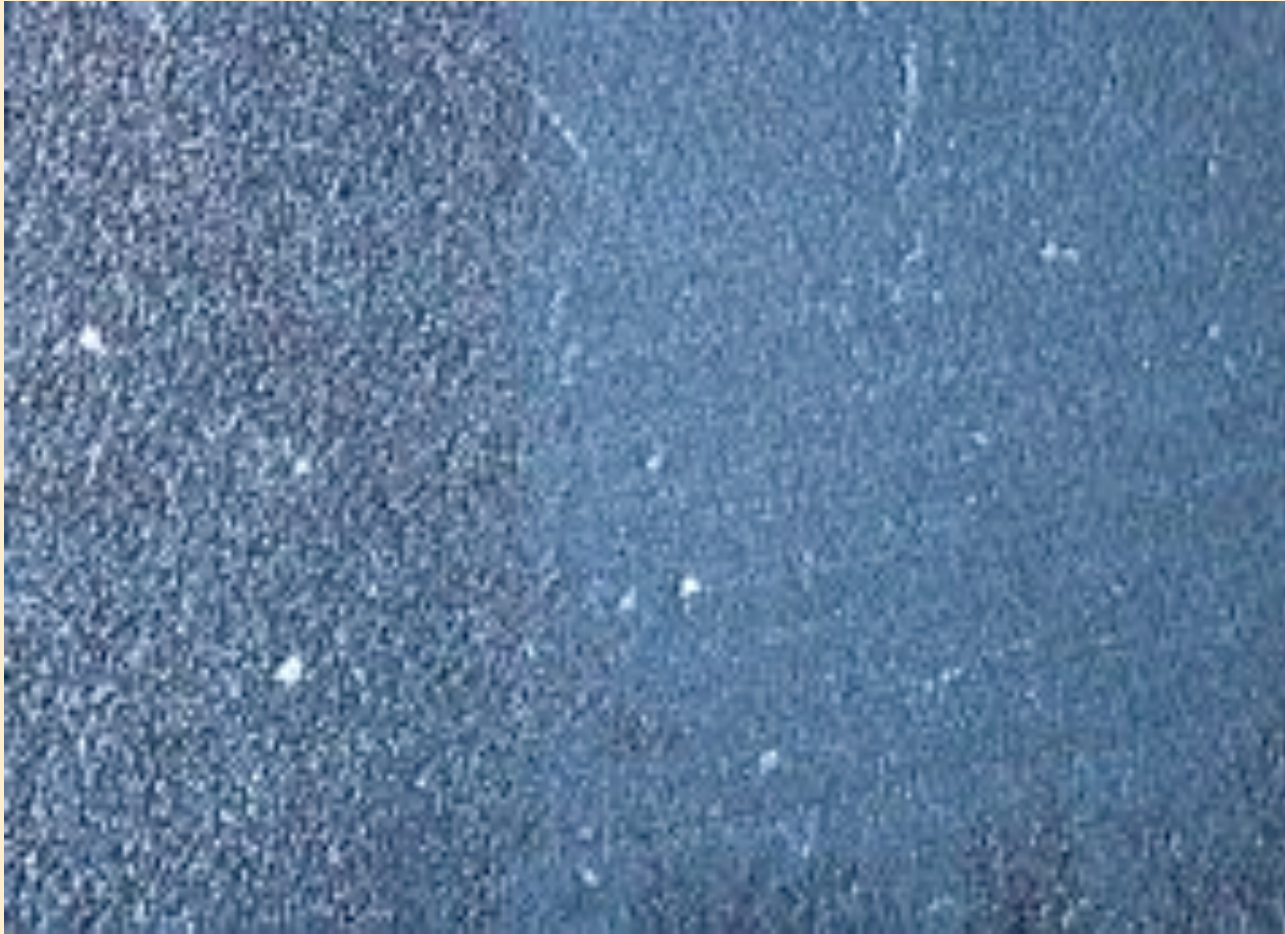
Left half is the remaining coating after acetone cleaning

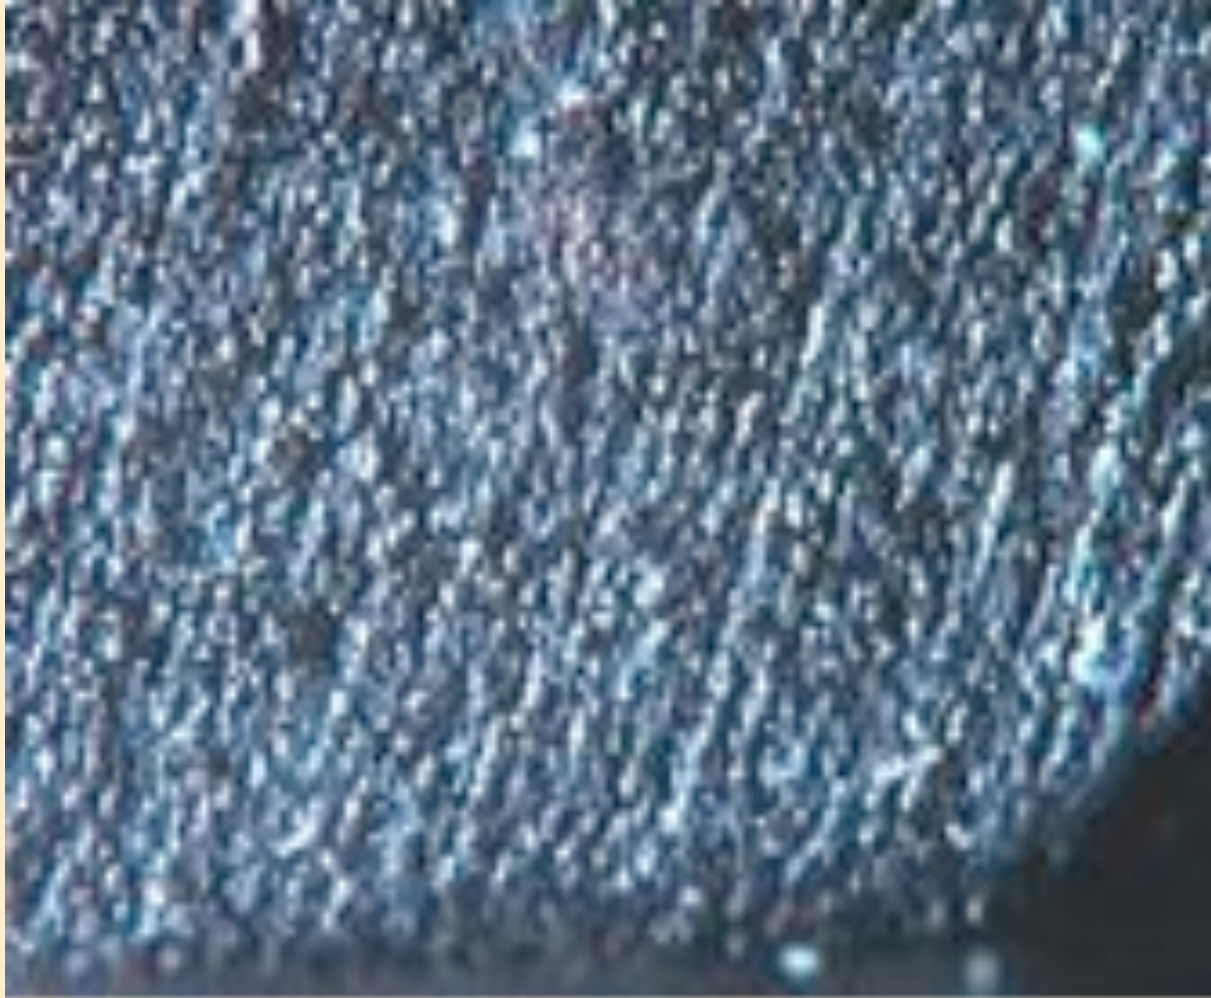
Obviously sanded and altered

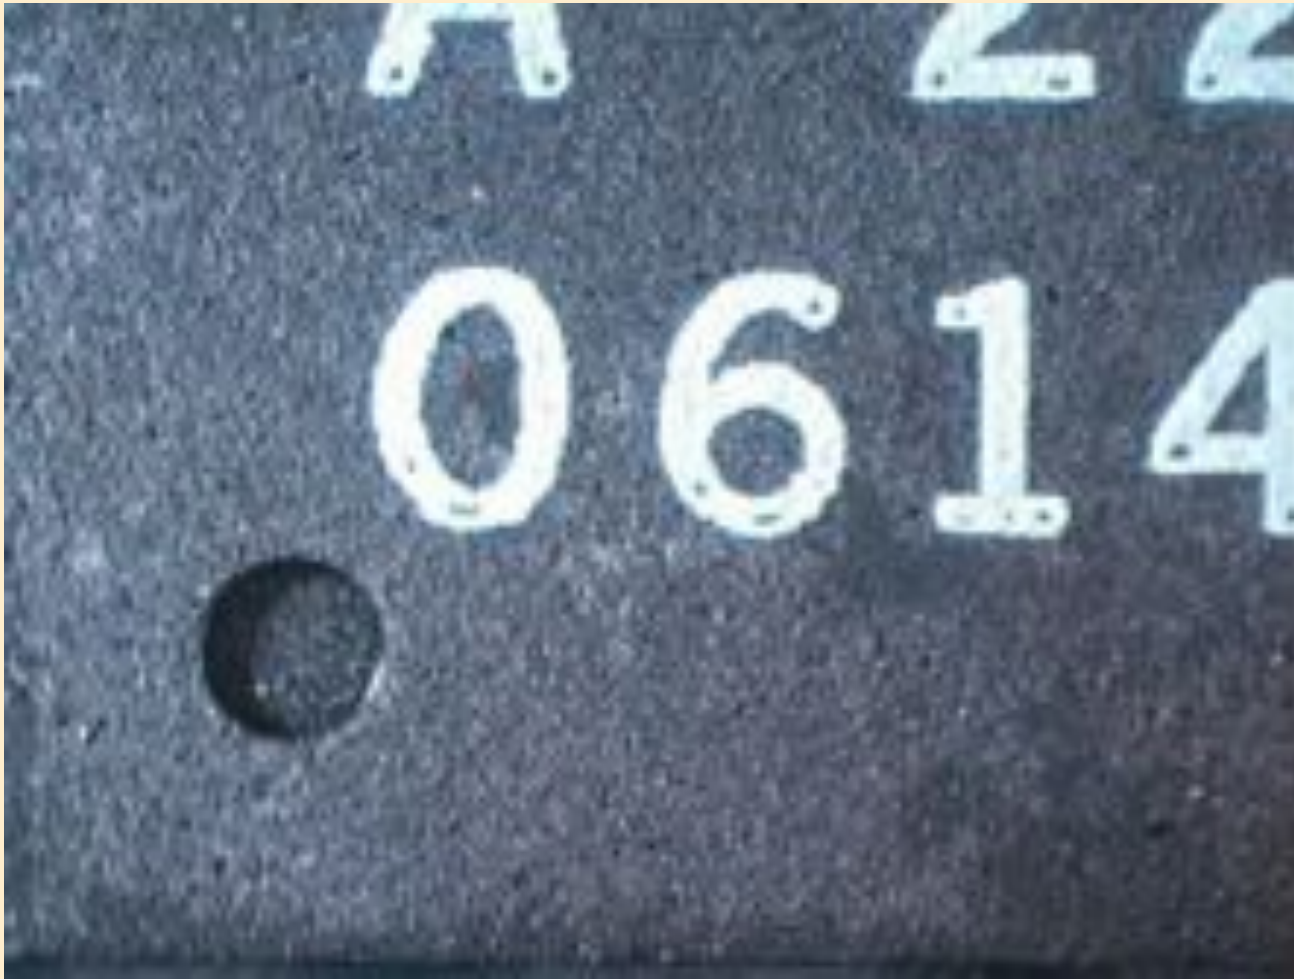
See a dull grainy appearance, it is apparent that the top surface has been altered.

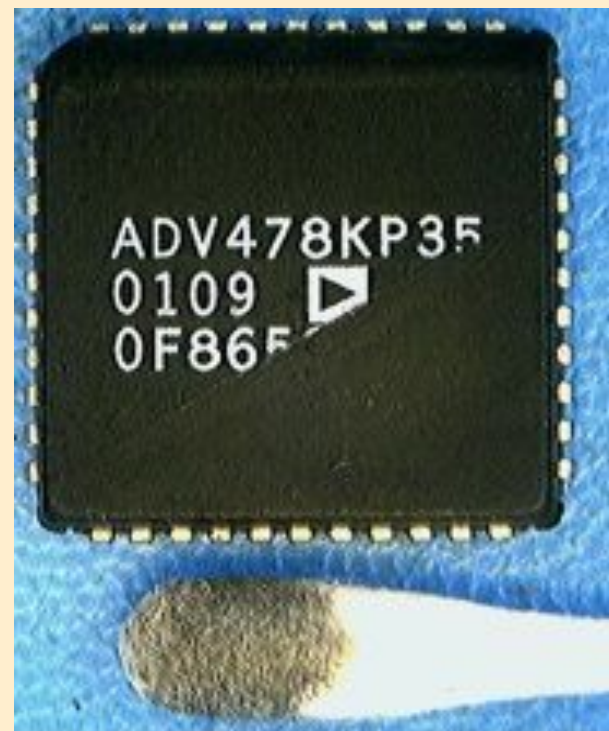
## **OBSOLETE, REMARKED**

- IC was discontinued about 1996; no licensed re-manufacturer.
- Parts likely electrically good, ruined by clean-up.
- Purchases several brokers deep. Stated they never had a complaint about electrical malfunction.
- Re-marking to raise price, update, or “clean-up.”
- Re-marking trademark, changes part to counterfeit.
- Samples sent to US Customs authorities.
- Manufacturer registered his logo with Customs.
- Surface Texture differential test - **failed**
- Pin 1 Dimple Reflectivity and Depth Test - **failed**
- Lead-form and Co-planarity Test - **failed**
- Mold Mark Reflectivity Test - **failed**
- Acetone Swab Test for Blacktopping - **failed**

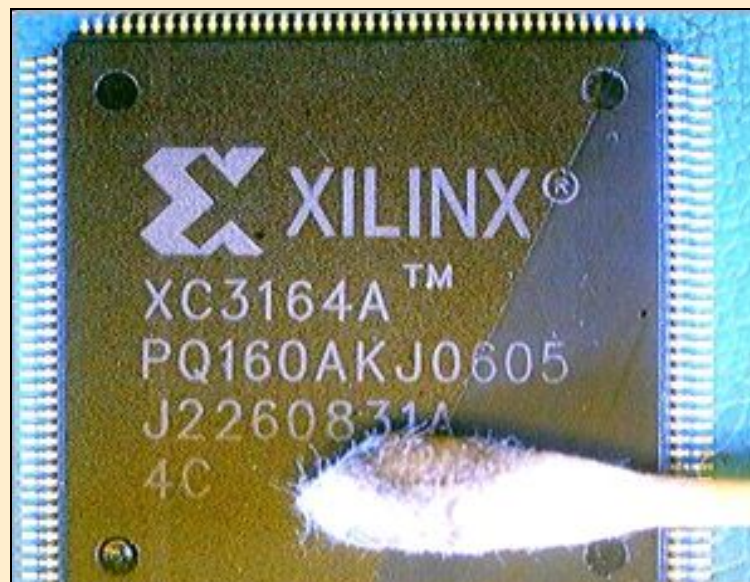
## OBSOLETE PART REMARKED.

- **FPGA**
- Blacktop fails acetone swab.
- Incoming flagged first shipment, sent parts back.
- Second shipment had same problem.
- Customer granted permission to use only after passing stringent sample testing plan.
- Part was remarked with lower-speed P/N in order to satisfy market demand.
- Still counterfeit per CCAP-101.

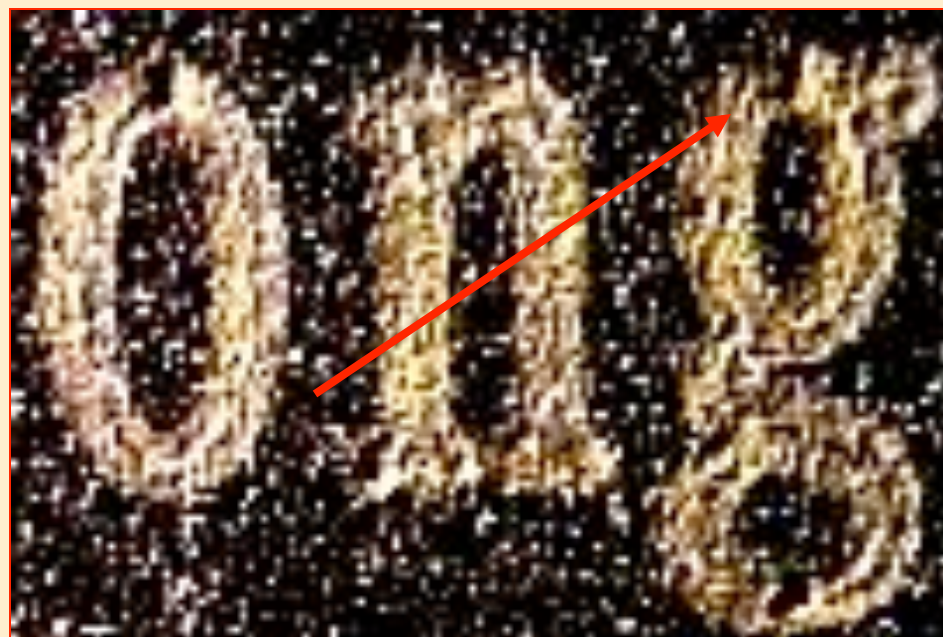
**Laser marking** needs to be looked at carefully. The problem is that not being the best funded operation they buy used and after market equipment for the laser marking and very often the result is poor.

The arrow points at a hole in surface created by the laser burn, the bonding wires could be seen through hole.

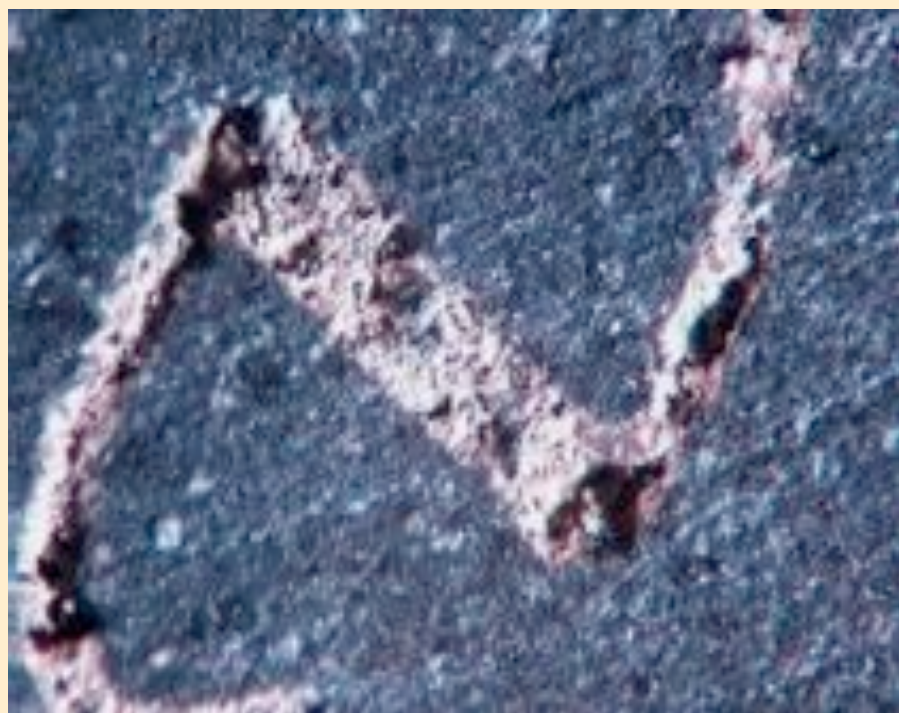
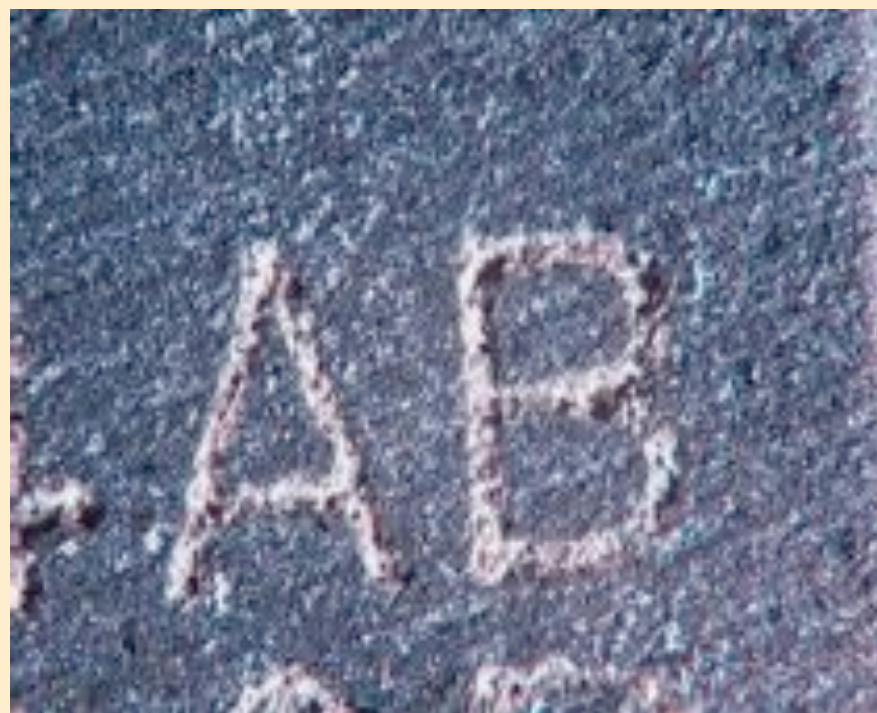
Based on the appearance of the previous slides, these are strongly suspect as have been fraudulently altered.

With chemical cleaning the surface coating comes off revealing the sanding marks beneath

When there is laser damage look closer- not typical of OCM.

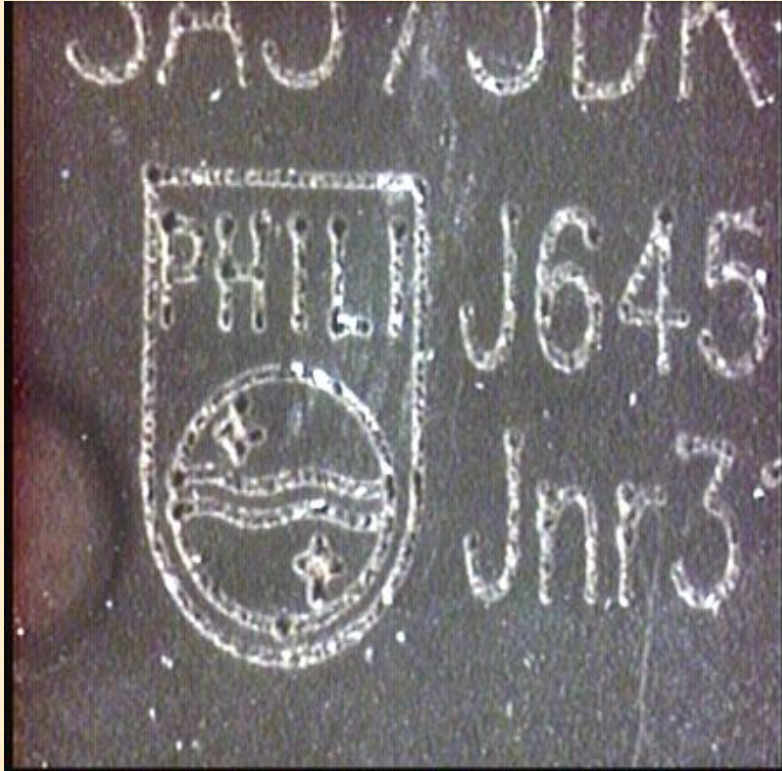
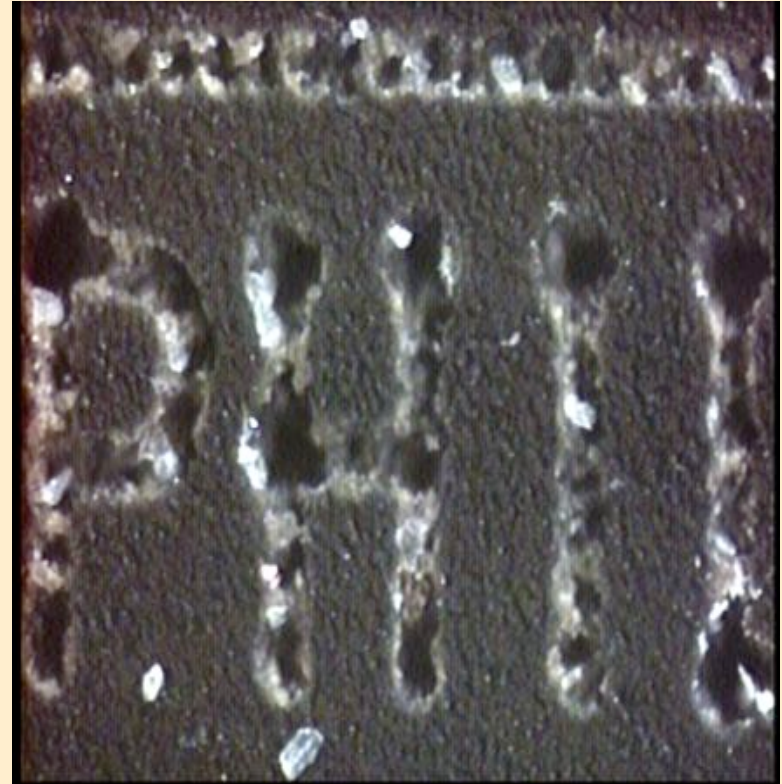
Most parts with Laser damage are in some way bogus, plus Philips would not abbreviate their logo. Decap revealed the chips were not original Philips, components were remarked.

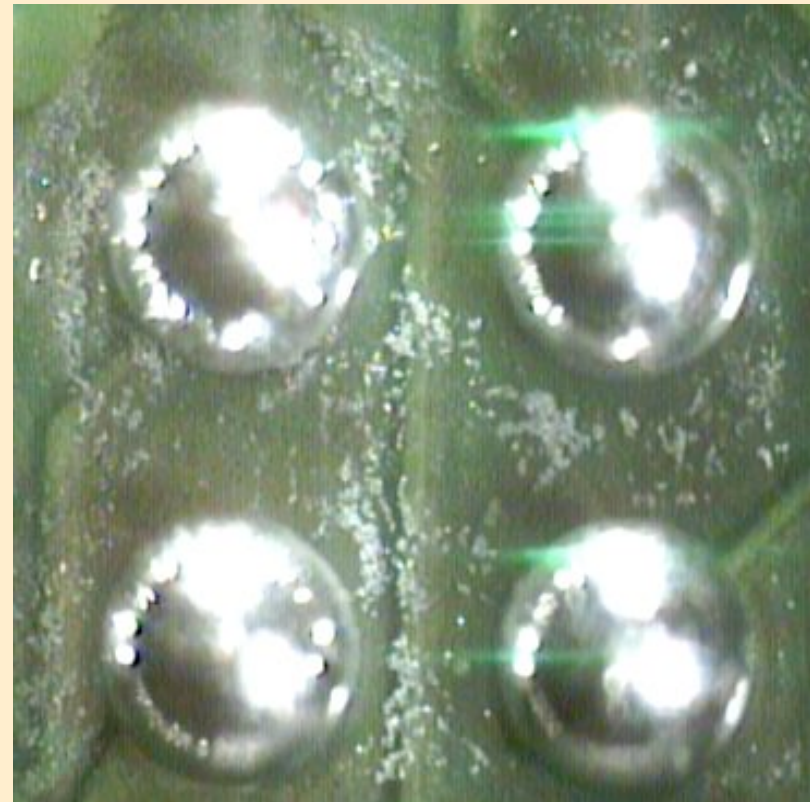
Probably residual flux

This type of damage or contamination should not be seen on supplied OEM part

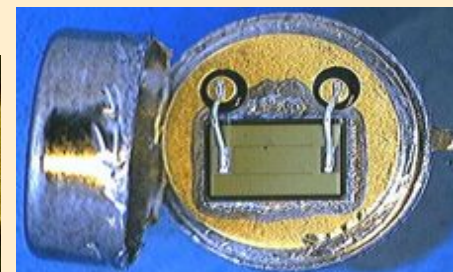
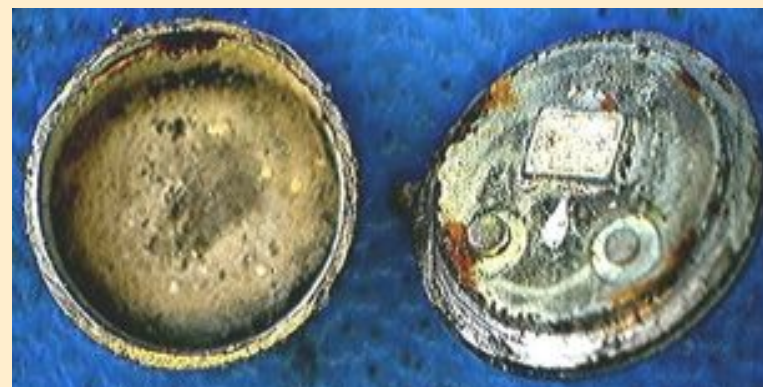
## JAN TX Counterfeit

- MIL / AERO field failure
- Obsolete. Purchased from broker. Unavailable from licensed re-manufacturers.
- Marking on D/C 0326 parts was amateurish, poor quality and illogical. No Harris or Intersil mil-grade parts made since 1999.
- Marking on D/C 9915 was good. One part out of 75 was sampled because of high unit cost.
- De-cap and internal visual showed no problems, but die too big should be 62x62.
- Markings on failed parts removed by acetone.
- All parts opened from failures had 3 different die sizes.
- Parts has Pb-Sn solder die bonds. Harris/ Intersil used only Au die bonds.
- Interior of parts was coated with PbO. Al wire bonds were corroded away and open.
- Parts are counterfeit and poorly manufactured.

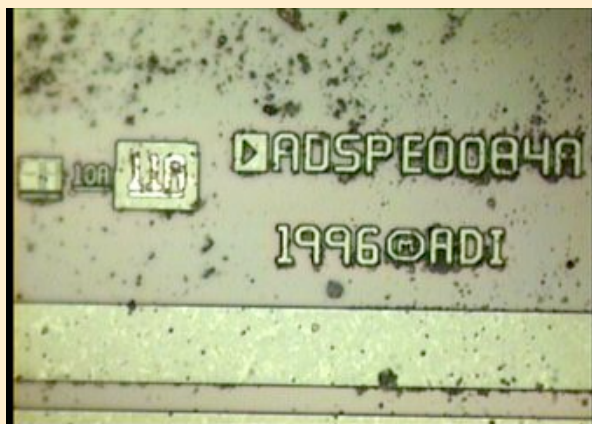
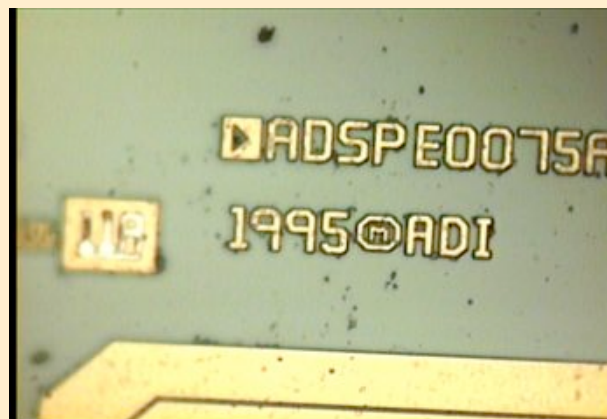
## Die Authentication

- Package markings were altered to ADSP-2100. Package date code was not recorded.
- Dice inside two example parts found to have correct OCM logos, but different mask numbers and dates.
- Legitimacy of these mask numbers for an ADSP-2100 P/N and package date code was apparently not researched.
- However, altered markings rendered the part counterfeit, and analysis could have stopped with only the visual inspection.
- Particles on surface of dice should have been removed with proper cleaning techniques after decap.

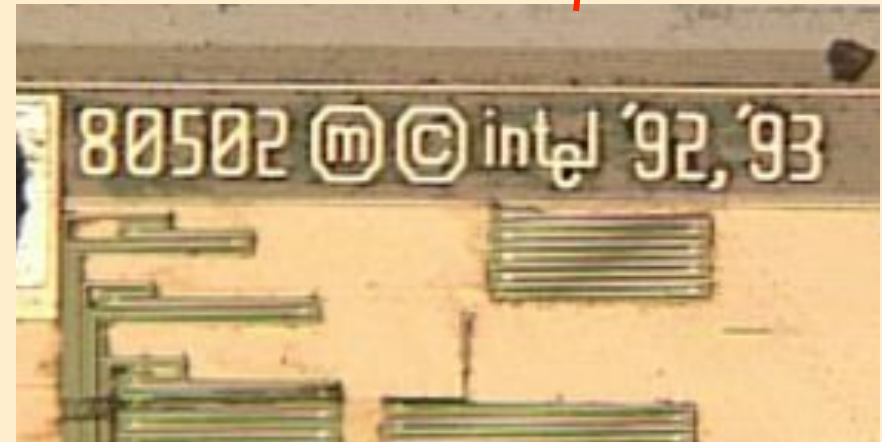
Here is the chip ID found after decap, looks good and matches the package marking

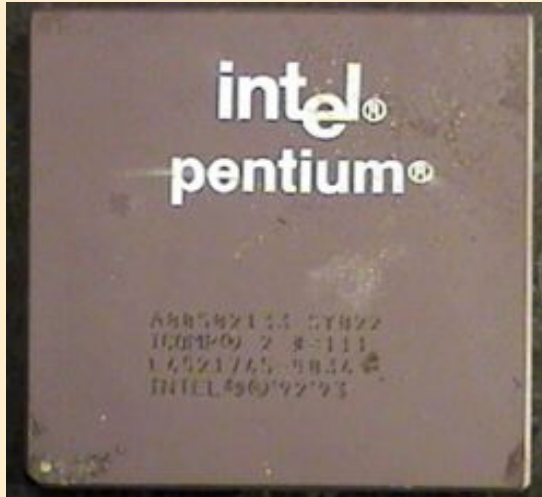
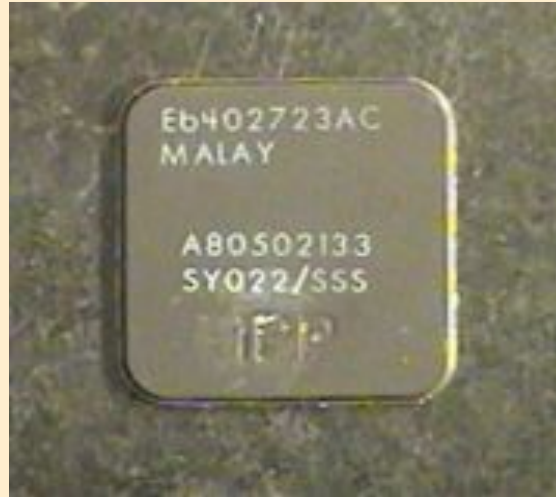
Same lot, same numbers but there is no ink dot

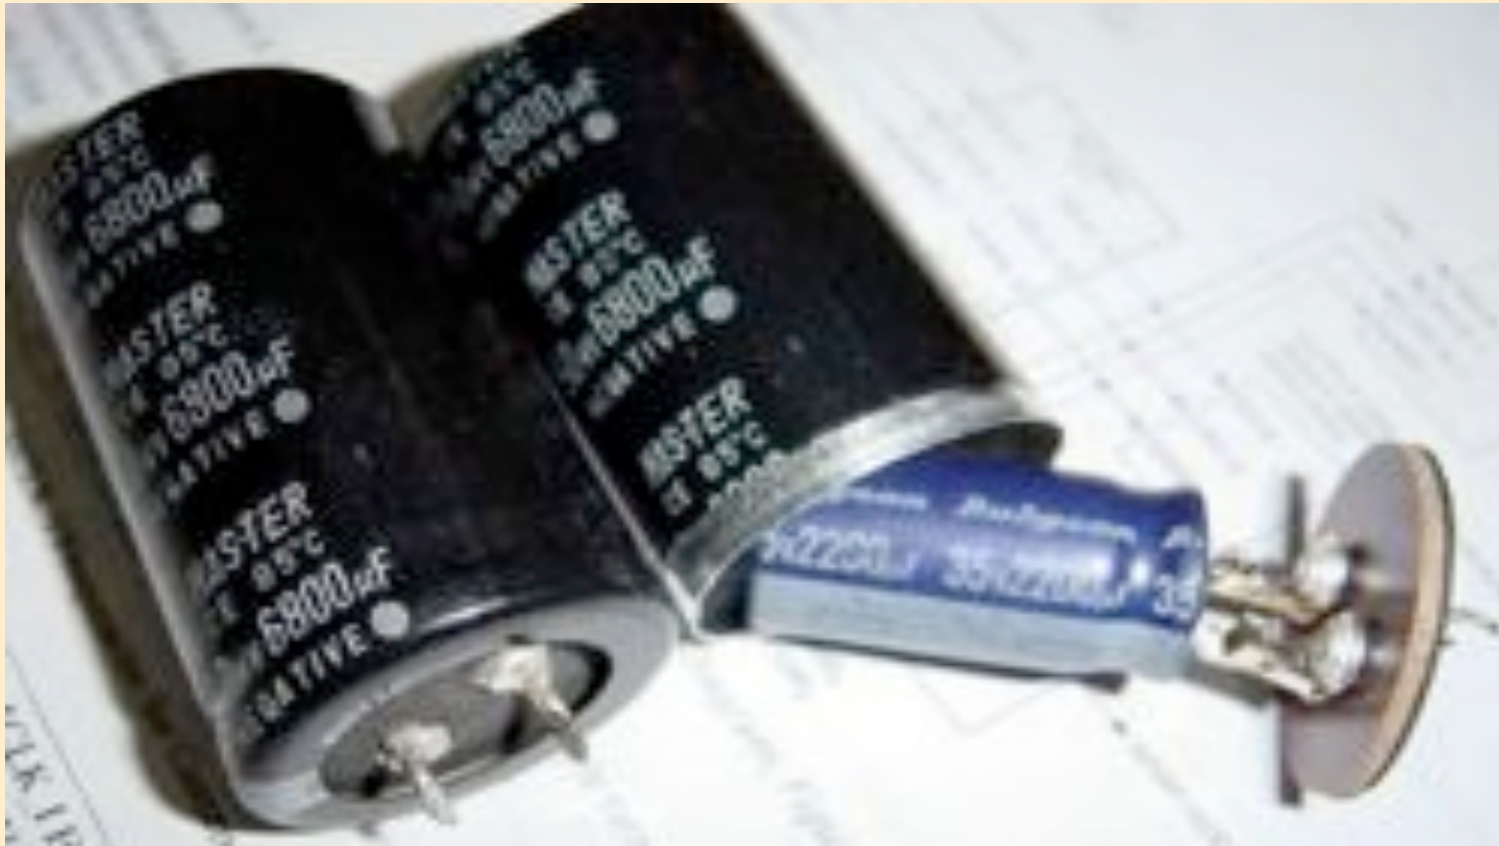
## Manufactured Fakes

- Capacitance measurement
- X-ray
- Decap

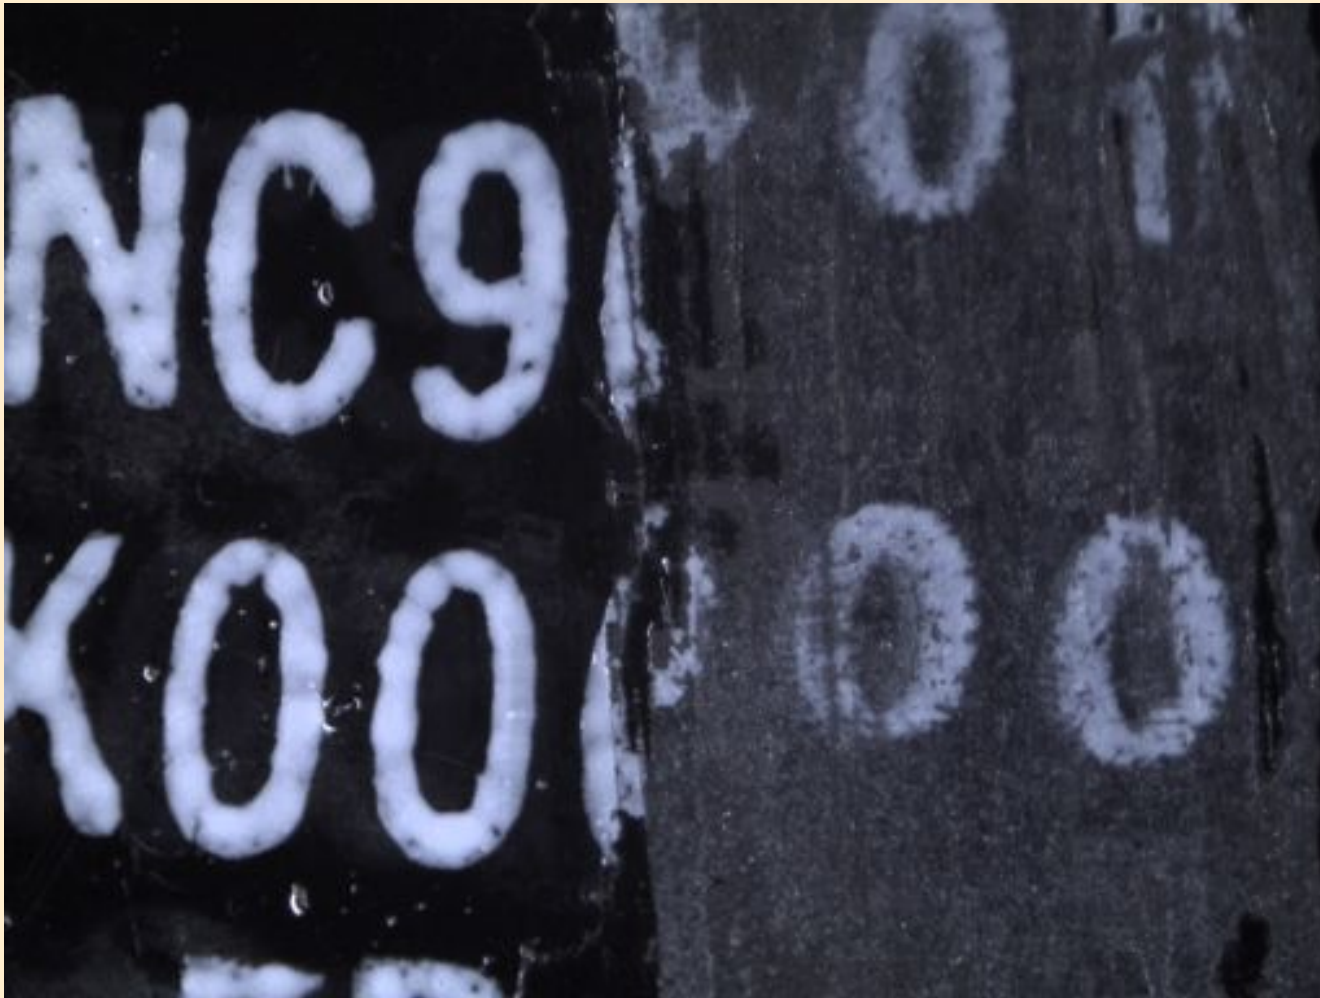
See original markings

Shows scratches from removal of epoxy markings
